# Manhole Inspection Summary

Manhole # S49I\_\_008MH

Insp Date: **4/1/08 10:54 AM**

**Location** Address: **2423 Eastern Av**

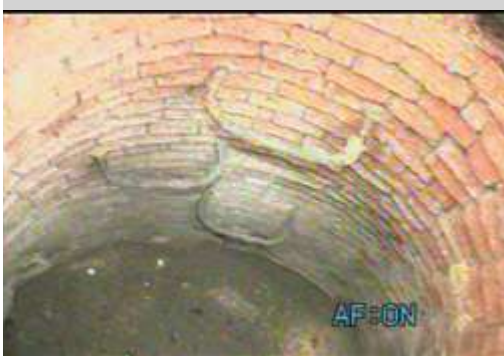
Defect 1

Count: **3** Missing: **0** ☒ **Corroded**

corroded stairs

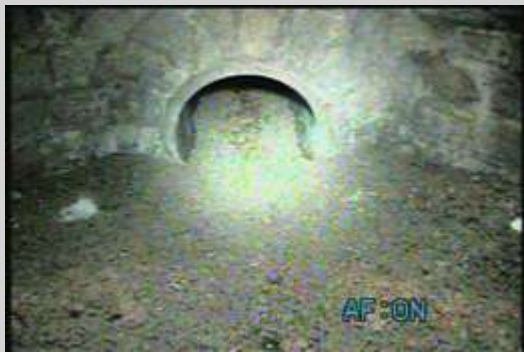
12 O'Clock Outflow

8 in. Circular Gravity Sewer  
Pipe Out @ 12 O'Clock

Pipe Material: **Clay** ☐ Pipe Lined

Deposits: ☒ None ☐ Mud ☐ Sludge ☐ Debris ☐ Grease

Infiltration: **None** Pipe Seal Cond: **Unknown**
